Forensic Structural Assessment of Madulla Bridge Failure, Sri Lanka

A.M.L.N. Gunathilaka^{1*}, P.A.K. Karunananda¹

¹Department of Civil Engineering, The Open University of Sri Lanka,
Nawala, Nugeoda, Sri Lanka.

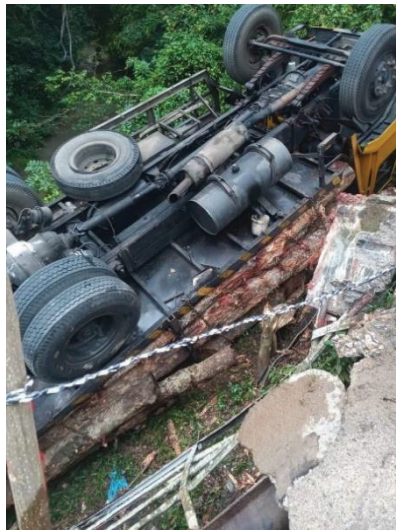
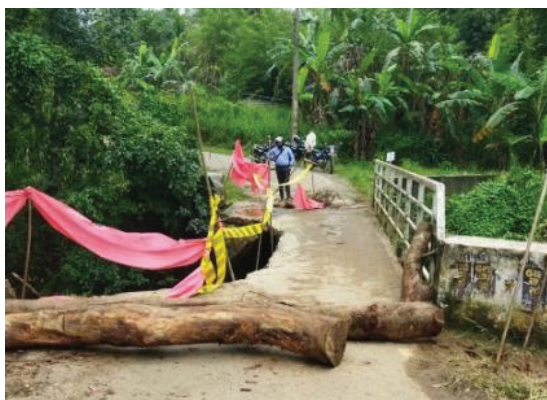
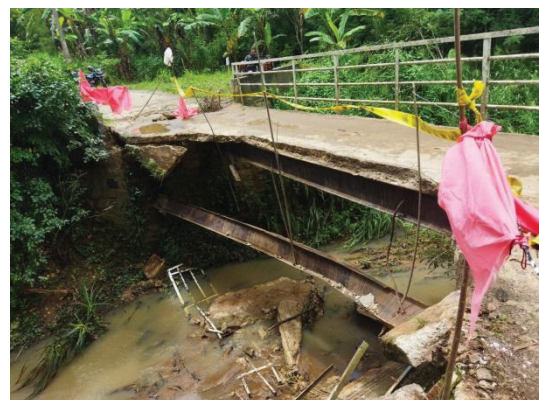
Part of the bridge (one supporting beam and portion of the top slab) had collapsed when an open truck full of timber logs was travelling on this bridge. Figure 4 shows a photograph of the truck travelling on the bridge at the time of failure and two views of the failed bridge. It was rationally assumed that the truck had approximate weight of 25 MT at the time of the failure (As per the manufacturer's specifications for the truck, the maximum load capacity of truck- Lanka Asoka Leyland Model No. 2516 including self-weight of the vehicle is 25 MT. when considers the load available on it at the time of failure, it could expect that truck was having load close to its load carrying capacity of 25 MT).

Fig. 4. Topped truck and failed bridge

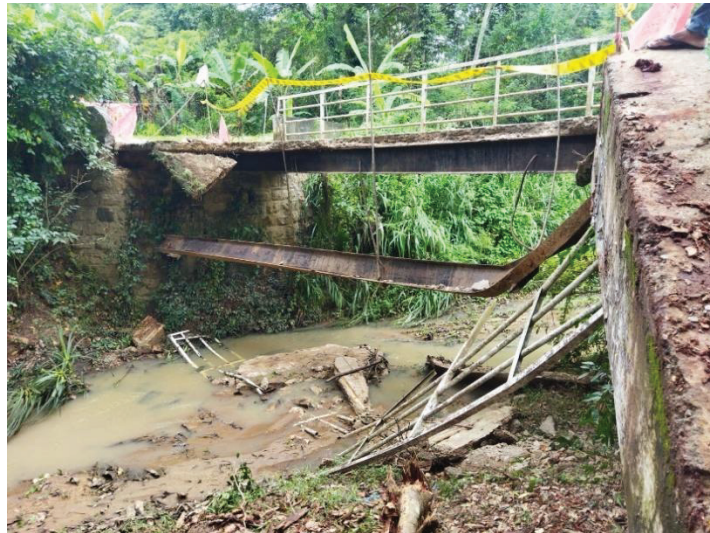
With objective of executing extensive root cause analysis for this failure, a careful visual inspection of remaining part of the bridge while obtaining possible measurements were performed by the authors. According to the investigation, extensive lateral deformation of failed steel beam was observed (see Fig. 5). It was further noted that portion of the deck slab collapsed along the edge of the mid beam as it can observe in Fig.4.

Fig. 5. Extensive later deformation of edge beam

According to the visual observation of the failure site, it was hinted that the ultimate failure of the bridge would have been caused by the lateral buckling of the supporting beam. If the ultimate failure was caused by the failure of deck slab, it could not expect such lateral deformation of the supporting beam. Also, the probability of occurring flexural failure of the beam would be rare as per the deformation pattern of the failed beam. However, it was decided to perform detailed structural assessment of the deck and the beam considering the probable loading on the slab to verify this.

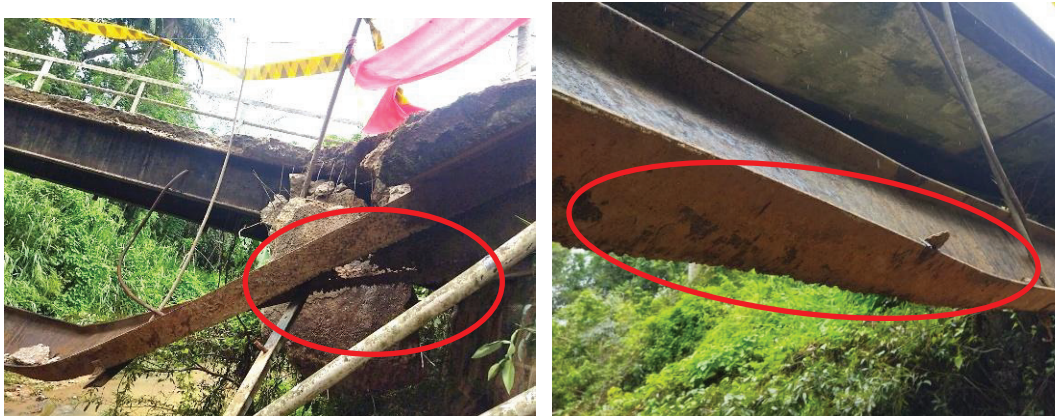
Also, a considerable amount of corrosion was noted in all three steel beams and area losses of steel beams due corrosion at certain locations were also noted. Deformed steel beam and badly corroded locations of that beam are shown in Fig. 6.

Fig. 6. Visible Corrosion and the area loss due corrosion of the deformed beam

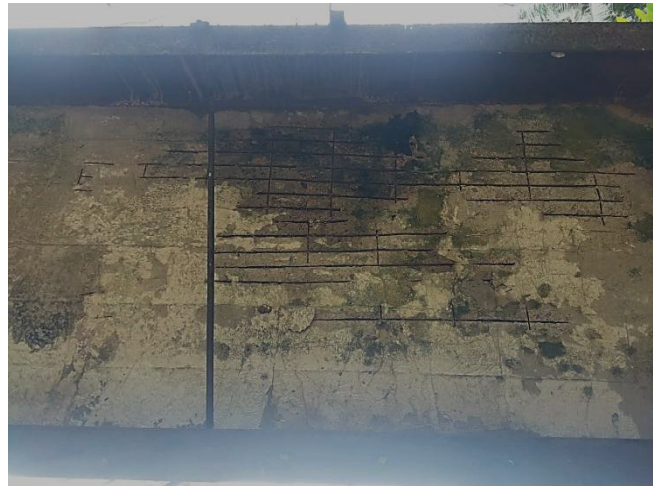
The soffit of the remaining part of the slab was also inspected and photograph of the soffit slab is presented in Fig. 7. Corrosion of reinforcement was clearly visible and insufficient cover for reinforcement seems to be the main cause for this corrosion. It was noted that the cover for reinforcements was less than 10mm in certain places.

Fig. 7. Exposed reinforcements of the deck slab

As per the visible reinforcements, it had provided main reinforcements parallel to the directions of beams at an approximate spacing of 100 mm. The spacing of distribution reinforcements, provided perpendicular to main reinforcements, was about 300mm. However, when it considers about load transferring pattern of the slab, this slab should have been designed as a one-way spanning slab spanning between steel beams even though reinforcements were provided otherwise as per observations. No top reinforcements were found in slab during the observation.

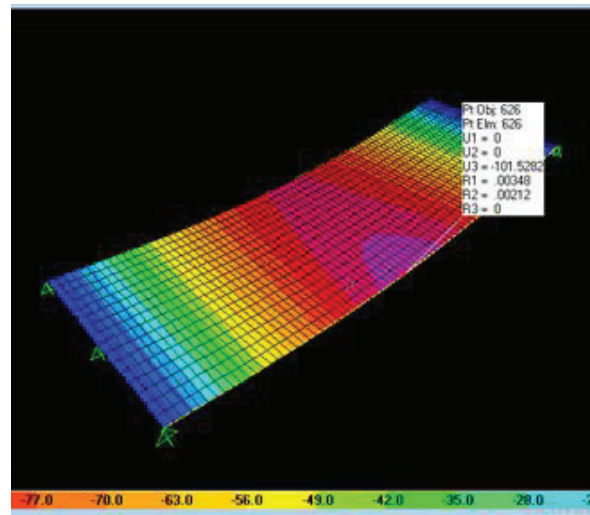
Fig. 11. Deformation of the deck

As per deflection contours of the analysis presented in Fig. 11, the maximum deflection of 101 mm was reported in the slab. This is an unacceptable service deflection as it violates specified allowable deflection limit of $L/200$ (60 mm) by a fair margin. The deflection contours have widened close to the edge where partial collapse of the bridge was observed at the site compared to the other edge. This would have led to uplifting of the slab from edges where minimum deflections were reported as there was no direct connection between concrete deck and beams in the actual structure.

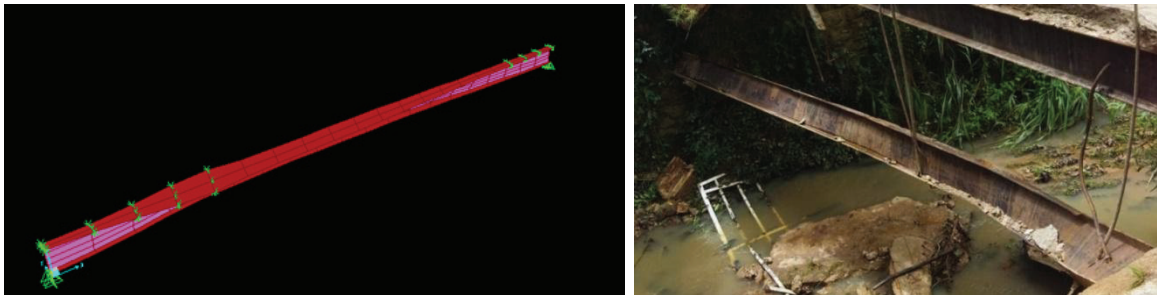
Hence, as already described, a buckling analysis of the edge beam was also performed developing a local model of the beam in SAP2000 v14. as presented in Figure 9. According to results of buckling analysis, Factor of Safety (FOS) of 0.48 was reported against buckling in the beam. The graphical results showing deformation of the beam under buckling analysis is shown in Figure 11(a) and the actual deformation observed in the beam at the site is shown in Figure 11(b). A reasonable match between the deformation pattern of analytical model and the actual beam can be observed. Further, a manual design check of Lateral Torsional Buckling (LTB) of the beam under this scenario was performed as per the approach specified in the BS5950:2000 and it also proved the structural inadequacy of the beam under LTB justifying the results of this modelling(see Table 2). Therefore, it provides a strong suggestion that the ultimate failure of the bridge would have been caused by the LTB of the considered beam once lateral restraint from the beam for the slab was lost by the excessive deformation and the possible local failure of the slab. Summary of results relevant to flexural capacity assessment of the beam is presented in Table 2.

* Hence, Ratio of reported BM/ BM capacity considering LTB = $1/0.48 = 2.08 \gg 1$

Fig. 11. Deformed shape of beam at end of the buckling analysis in SAP2000

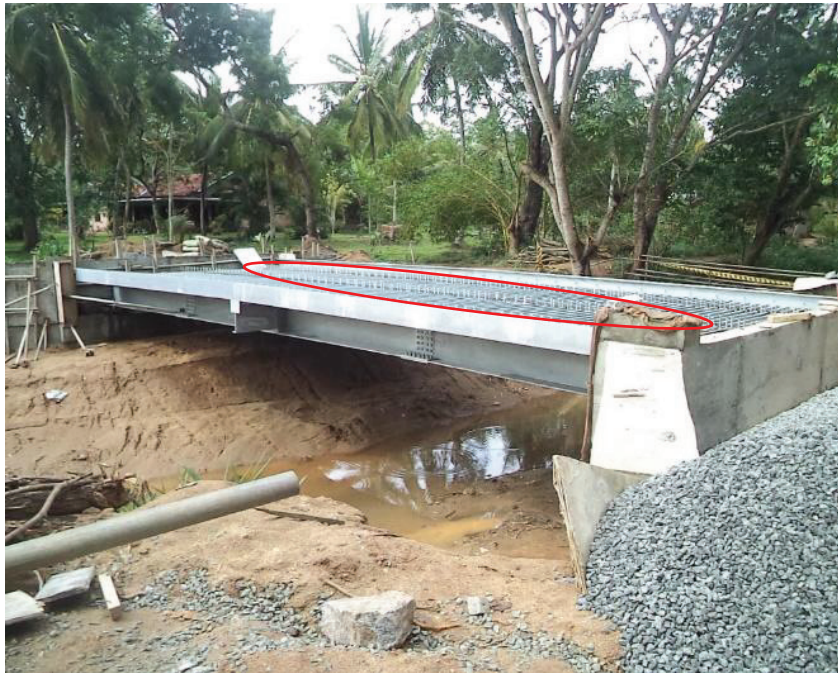
Fig. 12: Bridge deck of having shear studs welded to top flanges of supporting beams

Further, totally relying on friction between slab deck and steel beams for the prevention of LTB of beams would be another main factor that contributed to this failure. If a composite action between the slab deck and steel beams by means of shear studs or any other appropriate technique was available, the risk of overall failure would be considerably less. However, in recently constructed rural bridges with steel beams in Sri Lanka, shear studs were provided in top flanges in beams to ensure composite action. Fig. 12 shows photograph taken during a recent rural bridge construction and shear studs provided in top flange to connect deck slab is clearly visible here.

Hence, it is evident that this type of bridges would be vulnerable for this type of heavy loads. Lack of ultimate loads considered for original designs and non-provision of proper connection of the deck and the supporting beams would be the main probable reason for this vulnerability. Therefore, it emphasizes the need for the adaptation of composite bridge decks with the provision of shear studs as in present construction practice.
