# Assessment of Microplastic Pollution in the Kelani and Gin River Drinking Water Intake Points in Sri Lanka

**Abstract**— Microplastic pollution has become a growing concern in freshwater systems that supply drinking water. This study used a quantitative experimental design to assess the occurrence and preliminary characteristics of microplastics in the Kelani and Gin River drinking-water intake points in Sri Lanka. Water and surface sediment samples were collected from upstream, intake, and downstream locations, then processed by filtration, density separation, and phase-contrast microscopy. The observed particles were classified into four main morphologies: fibers, fragments, films, and pellets. In the reported counts, Kelani River water contained 48 fibers, 32 fragments, 25 films, and 34 pellets, while Gin River water contained 39 fibers, 34 fragments, 21 films, and 32 pellets; sediment samples showed lower overall counts but the same dominant morphologies. XRD was used only as a preliminary structural characterization technique; definitive polymer identification requires complementary techniques such as FTIR and SEM, which were not performed in the present study. The study pr

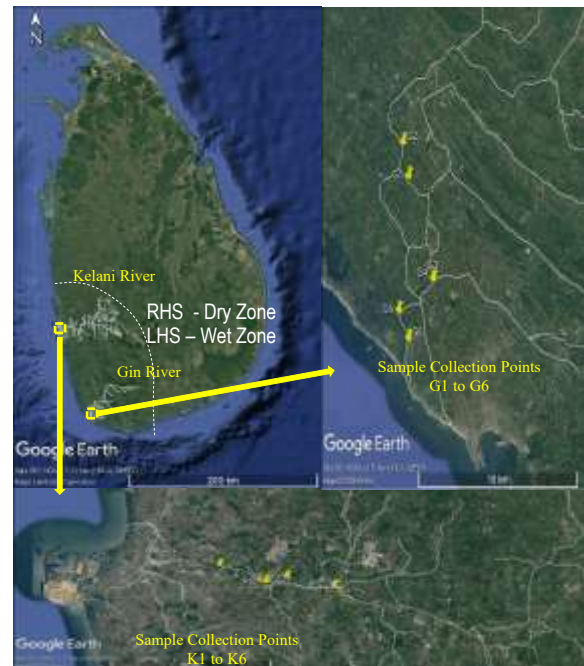
Figure 1 : Location of the Kelani and Gin River basins showing the selected drinking water intake sampling stations.

As indicated in Table 1, the Kelani River catchment is subjected to comparatively higher anthropogenic pressure due to extensive urbanization, industrial development, and population density within the lower basin [9]. These activities may introduce greater quantities of plastic waste, wastewater-derived contaminants, and urban runoff into the river system. In contrast, the Gin River represents a comparatively less urbanized catchment; however, agricultural activities, rural settlements, tourism, and downstream development may contribute to microplastic inputs [10]. Therefore, differences in catchment characteristics and human activities between these two rivers provide an important basis for evaluating spatial variations in microplastic contamination at drinking-water intake locations. Below, Figure 1 shows the selected water intake points of the Kelani and Gin rivers.

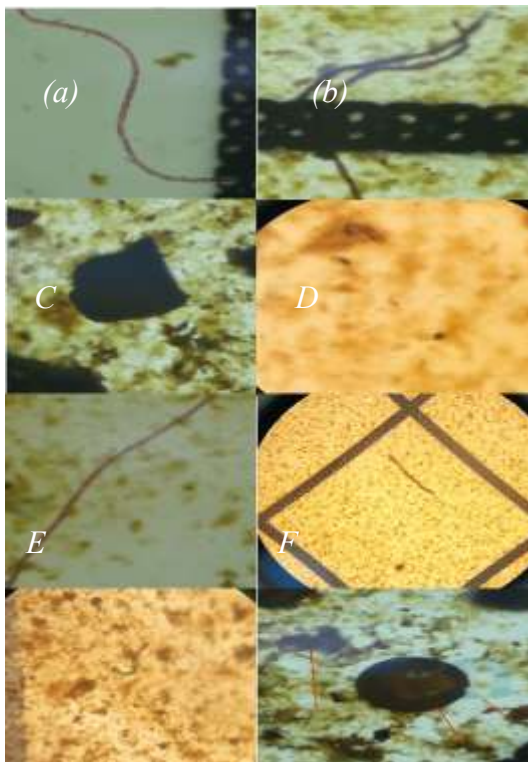
Figure 3 : Different shapes and color of MP Particles that find using Microscope a) Red Color fiber , b) Filaments , c) fiber ,d)pellets, e)rectangular shape particle , f, g) bio fouled fibers , g) green color fragment

Microplastic particles observed in the raw-water samples were predominantly within the reported size range of 0.05–5.0 mm. For the analyzed 100-L surface-water samples, the reported counts were 48 fibers, 32 fragments, 25 films, and 34 pellets for the Kelani River, and 39 fibers, 34 fragments, 21 films, and 32 pellets for the Gin River. Reporting the observations on a 100-L sample basis clarifies the sample volume associated with the reported counts. Fibrous particles were visually prominent, and blue was the dominant reported color among fibrous particles (>60%). Potential sources discussed in relation to the observed morphologies include wastewater inputs, atmospheric deposition, domestic laundry discharge, and physical fragmentation of larger plastic items. These pathways are considered plausible sources rather than direct source attribution.

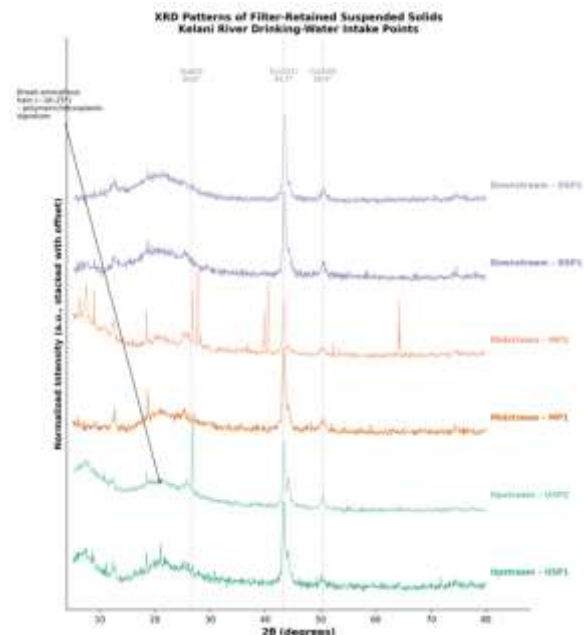
Figure 4 : XRD graph image take from Kelani River 6 water samples

XRD analysis was used as a preliminary structural characterization of selected retained particles. The diffraction patterns showed a broad hump between  $2\theta \approx 18$ – $25^\circ$ , together with crystalline peaks near  $2\theta \approx 26.6^\circ$  that were attributed to quartz from co-retained sediment. A recurring peak pair near  $2\theta \approx 43.3^\circ$  and  $50.4^\circ$  was observed across the samples and was attributed to the sample holder or mounting system; this should be verified using an appropriate blank-filter run. The present study did not perform FTIR or SEM analysis; therefore, specific polymer identities such as PE, PP, PET, and PS cannot be reported as definitively confirmed from the present dataset. Further work using FTIR and/or other validated polymer-identification techniques is recommended. The possible transport of microplastics through raw-water treatment systems therefore justifies continued monitoring and polymer-specific characterization.
