## ESTIMATING FLOW INEFFICIENCIES IN THE KADDUMURIVU IRRIGATION SYSTEM THROUGH INTEGRATED HYDRODYNAMIC MODELING AND REAL-TIME ON-SITE MEASUREMENTS

**Abstract**—Irrigation water scarcity in Sri Lanka is intensified by conveyance losses in unlined tank-cascade canals. This study quantifies flow inefficiencies in a 650 m reach of the Kaddumurivu Irrigation System (KIS) by integrating field measurements with a one-dimensional steady-flow HEC-RAS model. Eight canal stations were surveyed using a Total Station, while discharge and water-surface elevations were measured under steady operating conditions using a current meter and staff gauges. The model was calibrated by adjusting Manning's roughness coefficient until simulated water-surface elevations agreed with observations within  $\pm 0.05$  m and was subsequently validated using an independent flow dataset. The measured discharge decreased from 1.0052 m<sup>3</sup>/s upstream to 0.7681 m<sup>3</sup>/s downstream, giving a volumetric loss of 0.2371 m<sup>3</sup>/s equivalent to 23.6% of inflow, and a conveyance efficiency of 76.4%. Energy-based analysis gave a total head loss of 0.30 m, of which 0.12 m was attributed to friction and

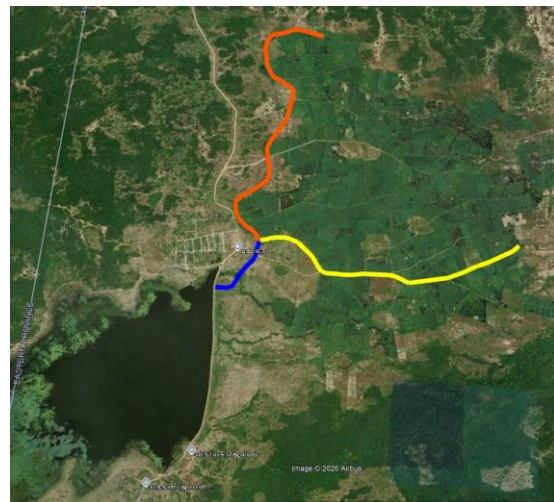
Fig. 1. Kaddumurivu Tank and the main canal study reach.

The Kaddumurivu Irrigation System (KIS) is a representative case: its 650 m main-canal study reach contains a 125 m concrete-lined central section between unlined earthen reaches. Following expansion of the command area, tail-end shortages have become a practical concern for farmers in the lower reaches. Previous investigations have identified seepage, evaporation, operational losses, and possible unauthorized abstractions as the principal non-friction mechanisms that may reduce delivery efficiency in such systems [4]. However, no systematic, physically grounded study has been conducted to quantify these losses or determine their underlying causes in the KIS.

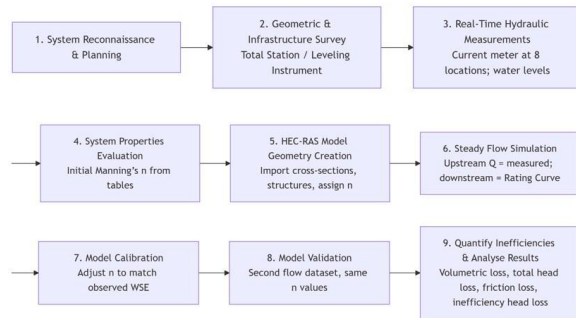
Fig. 2. Overall field measurement, modelling and inefficiency-analysis workflow.

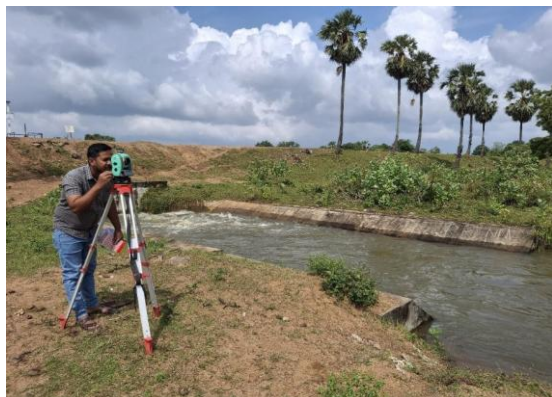
Fig. 3. Total Station surveying along the Kaddumurivu main canal.

The investigation covered a 650 m reach of the main canal, from River Station (RS) 650 upstream to RS 0 downstream. Eight cross-sections were surveyed, including the boundaries of the concrete-lined section and the location of the pipe culvert. Field measurements were carried out under representative steady operating conditions. Cross-sectional geometry was obtained with a Total Station, while discharge was measured using a current meter following the velocity-area method. Water-surface elevations were recorded concurrently to support model calibration.

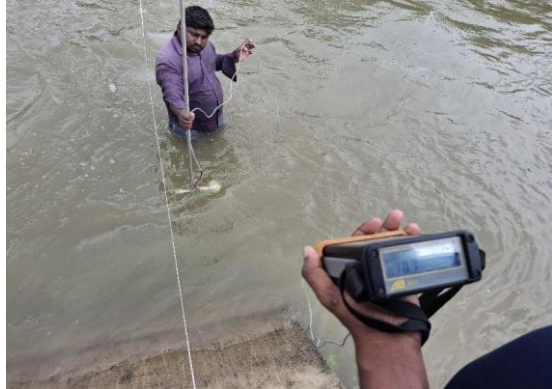
Fig. 4. Current-meter discharge measurement in the canal.

For each measurement station, the channel was divided into vertical segments. Local depth, velocity and partial area were used to calculate partial discharges, which were summed to obtain station discharge. The study also developed a stage-discharge relationship at the downstream gauge using

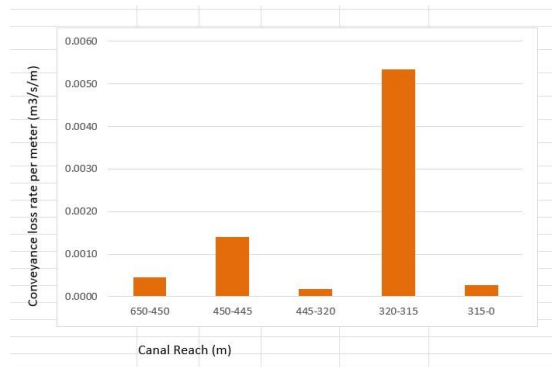
Fig. 5. Conveyance loss rate along the canal sections.

Table I summarizes the spatial distribution of conveyance losses along the canal reaches. The reach-scale loss rates demonstrate why spatial analysis is more informative than a single overall efficiency value. The 125 m concrete-lined section had the lowest loss rate (0.00018 m<sup>3</sup>/s/m), whereas the two 5 m transition reaches had disproportionately large losses per metre (0.0014 and 0.0054 m<sup>3</sup>/s/m). The 315 m lower unlined

The spatial results identified two short 5 m segments with unusually high loss rates: approximately 0.0014 m<sup>3</sup>/s/m near the upstream lining transition and 0.0054 m<sup>3</sup>/s/m around the culvert transition. The lower unlined reach contributed about 14.8% of the inflow as cumulative loss, whereas the concrete-lined reach had a much lower loss rate of about 0.00018 m<sup>3</sup>/s/m. The sharp local reductions suggest that structural leakage, uncontrolled diversion or transition effects should be investigated separately from diffuse seepage.

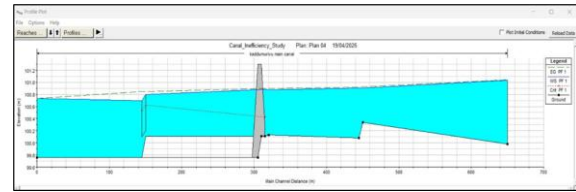
Fig. 6. HEC-RAS longitudinal profile after calibration.

The calibrated model reproduced the measured water-surface trend along the study reach and represented the pipe culvert explicitly. The close agreement between computed and observed levels indicates that the selected geometry and calibrated roughness values were adequate for the diagnostic purpose of the study. The independent validation dataset retained the same geometry and roughness parameters, providing an additional check that the calibration was not simply fitted to one field observation set.

The calibrated Manning's *n* values were 0.039 for the upper unlined reach (RS 650–450), 0.012 for the concrete-lined midsection (RS 445–320), and 0.020 for the lower unlined reach (RS 315–0). The relatively high upper-reach value is consistent with field observations of vegetation and irregular bed conditions. The low value for the concrete-lined section reflects its smoother hydraulic boundary. The lower unlined reach had a moderate roughness coefficient, indicating that its large water loss cannot be explained by friction alone. The model reproduced observed water-surface elevations within  $\pm 0.05$  m, and validation with an independent dataset confirmed the model's reliability for diagnostic analysis.
