Forensic Structural Assessment of Madulla Bridge Failure, Sri Lanka

A.M.L.N. Gunathilaka^{1*}, P.A.K. Karunananda¹

¹Department of Civil Engineering, The Open University of Sri Lanka,
Nawala, Nugeoda, Sri Lanka.

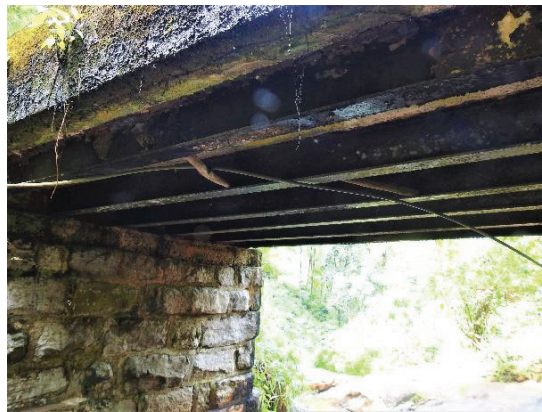
Fig. 1. An existing composite beam bridge in rural road in Sabaragamuwa province

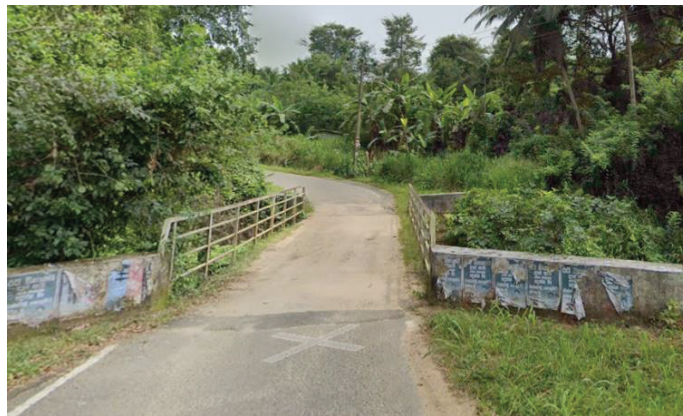
Fig. 2. A view of the Madulla bridge before failure

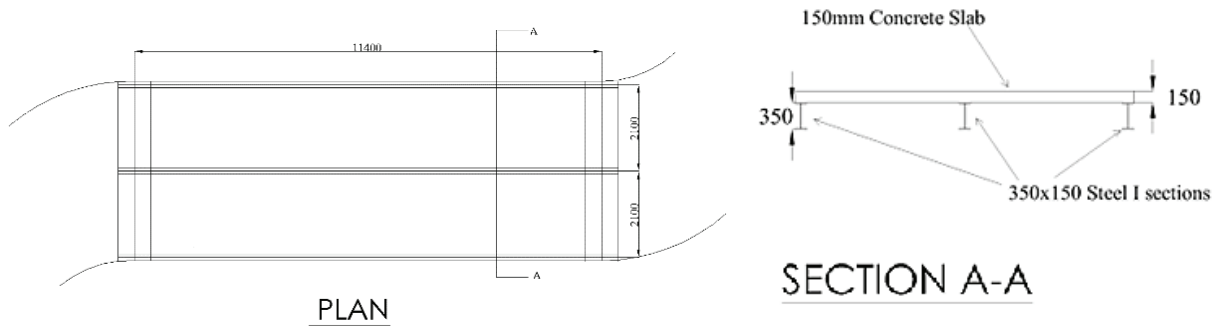
Fig. 3. Layout of the bridge

The failed bridge was located in Meegahapitiya- Kottagala Class C road in Madulla area of Monaragala district, Sri Lanka. The maintenance, repair and rehabilitation of this bridge comes under the purview of Provincial Road Development Authority of Uva province of Sri Lanka. The span of the bridge is about 12 m and the bridge width is about 4.2 m. 150 mm thick concrete slab supported on three steel beams had been used as the bridge deck . A view of the bridge before failure is shown in Figure 2. Typical structural details of the bridge are presented as Fig.3.

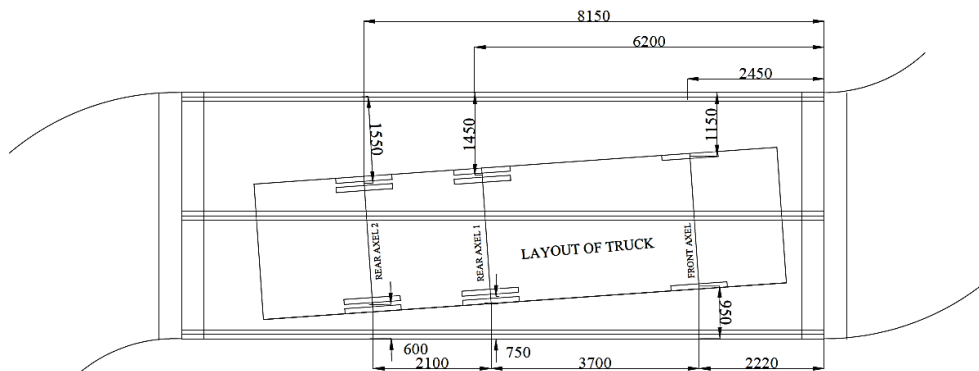
It is very difficult to simulate the exact load condition of the bridge at the time of failure. However, considering the position of the toppled vehicle after the incident, road geometry of the location and geometric details of the vehicle and the bridge, probable layout of the vehicle on the bridge at the time of failure was developed and presented in Fig.8.

Fig. 8. The probable layout of the truck at time of the bridge failure

As per vehicle specifications of this truck model, the front and rear axle loads are 9000kg and 16,000kg respectively under its full load capacity. Since this vehicle is having two rear axles, it can assume that each rear axle is bearing load of 8000kg. As already mentioned, it can rationally assume that truck was at its full load capacity at the time of the incident. Hence, it was decided to perform a static load analysis of the bridge considering these assumed loads and the developed layout as a forensic engineering analysis.

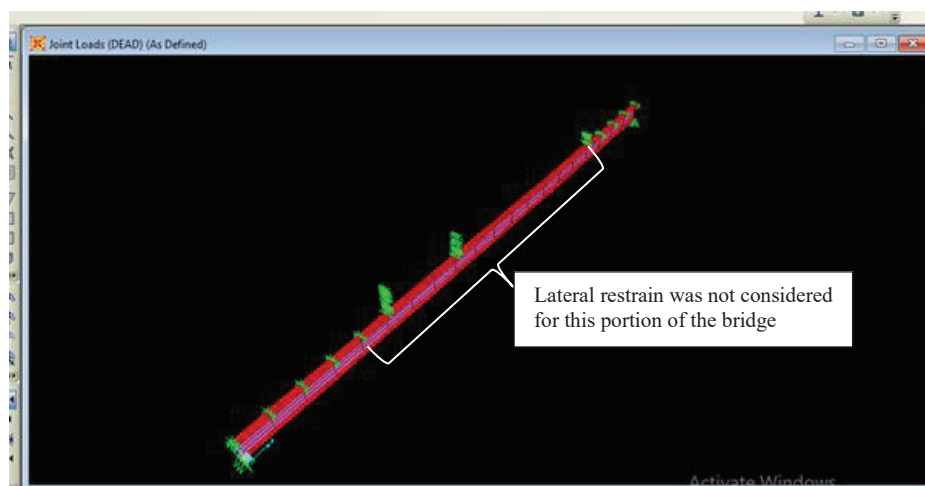
As considerable lateral deformation was observed in the beam that was collapsed during the incident, a separate buckling analysis of that beam was performed using the buckling analysis tool provided in the SAP 2000 v.14. In this regard, an analytical model was developed for the beam using thin two dimensional (2D) four node shell elements to perform the buckling analysis of the beam. The actual thickness of web area and the flanges that were noted at the site were assigned to respective shell elements. The SAP2000 numerical model developed to simulate buckling of the beam is shown in Fig.9.

Fig. 9. Prepared numerical model of failed beam

Hence, as already described, a buckling analysis of the edge beam was also performed developing a local model of the beam in SAP2000 v14. as presented in Figure 9. According to results of buckling analysis, Factor of Safety (FOS) of 0.48 was reported against buckling in the beam. The graphical results showing deformation of the beam under buckling analysis is shown in Figure 11(a) and the actual deformation observed in the beam at the site is shown in Figure 11(b). A reasonable match between the deformation pattern of analytical model and the actual beam can be observed. Further, a manual design check of Lateral Torsional Buckling (LTB) of the beam under this scenario was performed as per the approach specified in the BS5950:2000 and it also proved the structural inadequacy of the beam under LTB justifying the results of this modelling(see Table 2). Therefore, it provides a strong suggestion that the ultimate failure of the bridge would have been caused by the LTB of the considered beam once lateral restraint from the beam for the slab was lost by the excessive deformation and the possible local failure of the slab. Summary of results relevant to flexural capacity assessment of the beam is presented in Table 2.

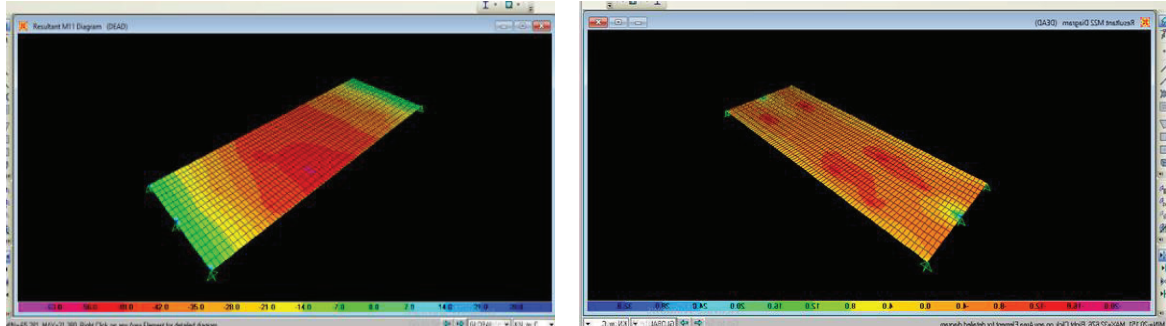
Fig. 10 shows the resulting bending moments of the bridge deck extracted from the 3D model developed for the bridge in graphical form. Figure 11 shows the deflection contours reported in the bridge model.

Fig. 10. Prepared numerical model of the bridge deck

According to the design verification, reported bending moments have exceeded the flexural capacity of the slab by considerable margins in both directions under this loading condition (This would have been further worsened if the corrosion effects of reinforcements were considered for the design verification). Accordingly, probable local failure would have taken place in the edge slab panel where above maximum bending moments were reported. Such failure would have also contributed for losing of lateral restraint to the edge beam.
